Re: April 2012 Monthly Progress Report  
Administrative Settlement Agreement and Order on Consent for Removal Action  
U.S. EPA Region 10 Docket No. CERCLA 10-2009-0255  
Gasco Sediments Site within the Portland Harbor Superfund Site

## Visual Observations Log Form

**Project Name:** NW Natural – Gasco

**Monitoring Period:** Monthly (Year 6)—April 2012

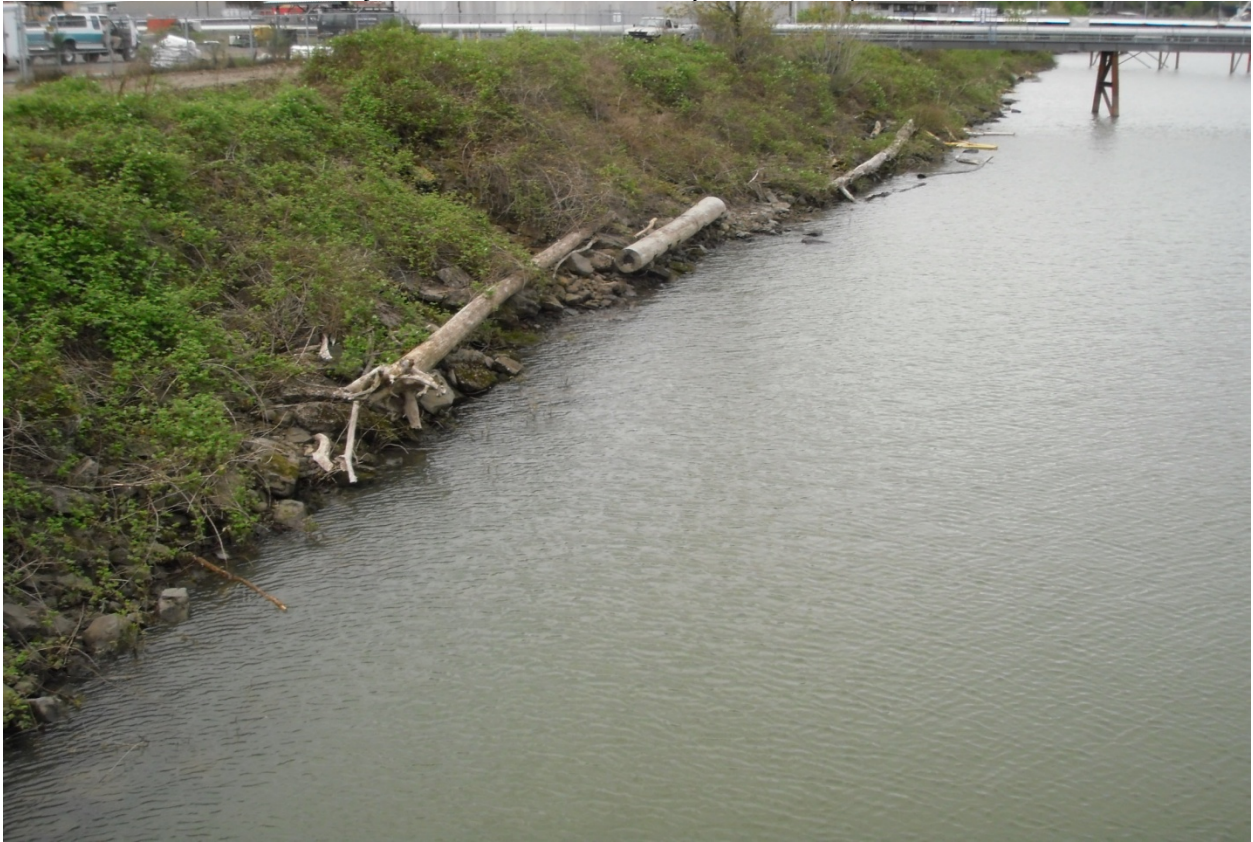
**Observations of Erosion/Deposition:** No erosion/deposition is evident along the shoreline. The shoreward extent of the cap was not visible due to high river water elevation; and the extents of the organoclay mat material footprint were also submerged. (Photo 1).

Photo 1 — *River level currently elevated above the extent of sediment cap (4/24/12):*

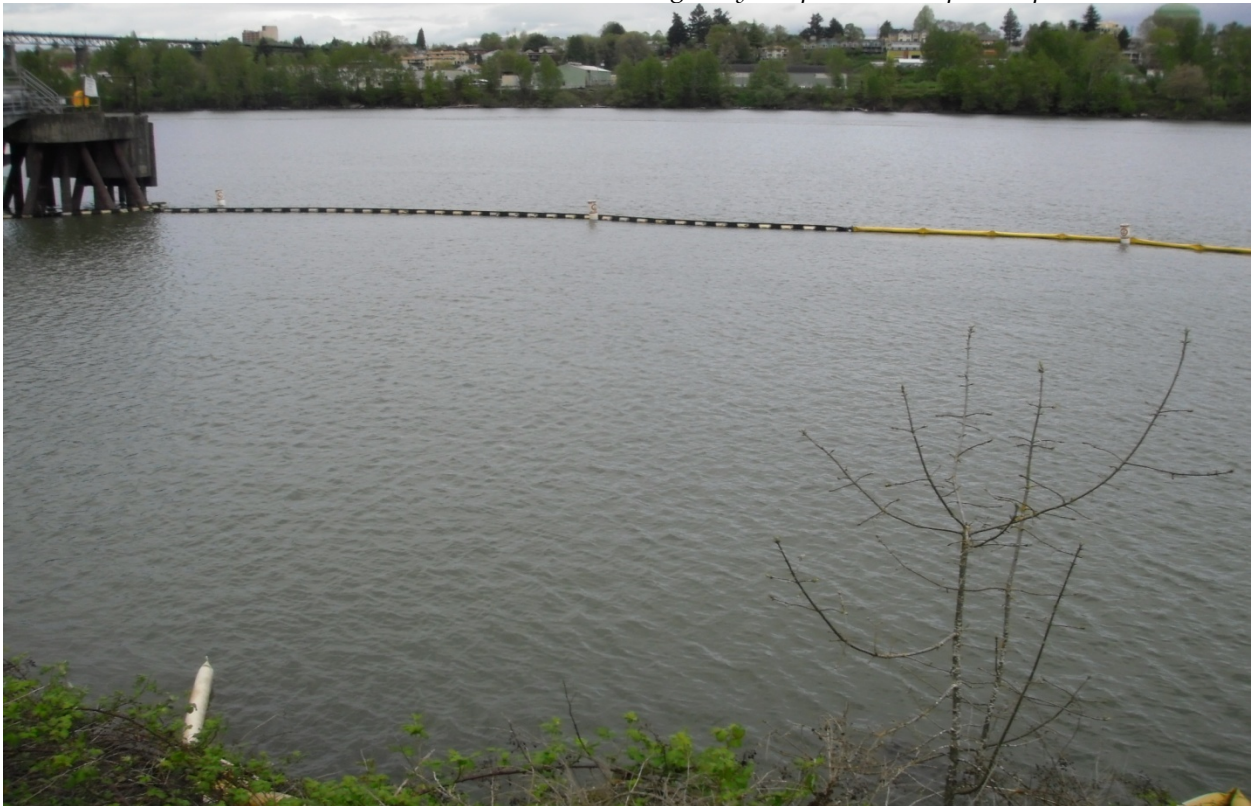
**Observations of Long-term Controls (i.e., oil booms, organo-clay mat, etc.)** During the observation, the Fuel and Marine Marketing (FAMM) containment boom was placed across the cap area, between the upriver corner of the ship dock and the wooden dolphin (near the upriver extent of the site and near the Siltronic Corporation outfall. Buoys that identify the cap area to mariners are in place as installed. The position of the FAMM oil boom, warning buoys, and a general overview of the site shoreline is shown in Photo 2.

Photo 2 — *FAMM oil boom shown and mariner warning buoys in place across pilot cap area. (4/24/12):*

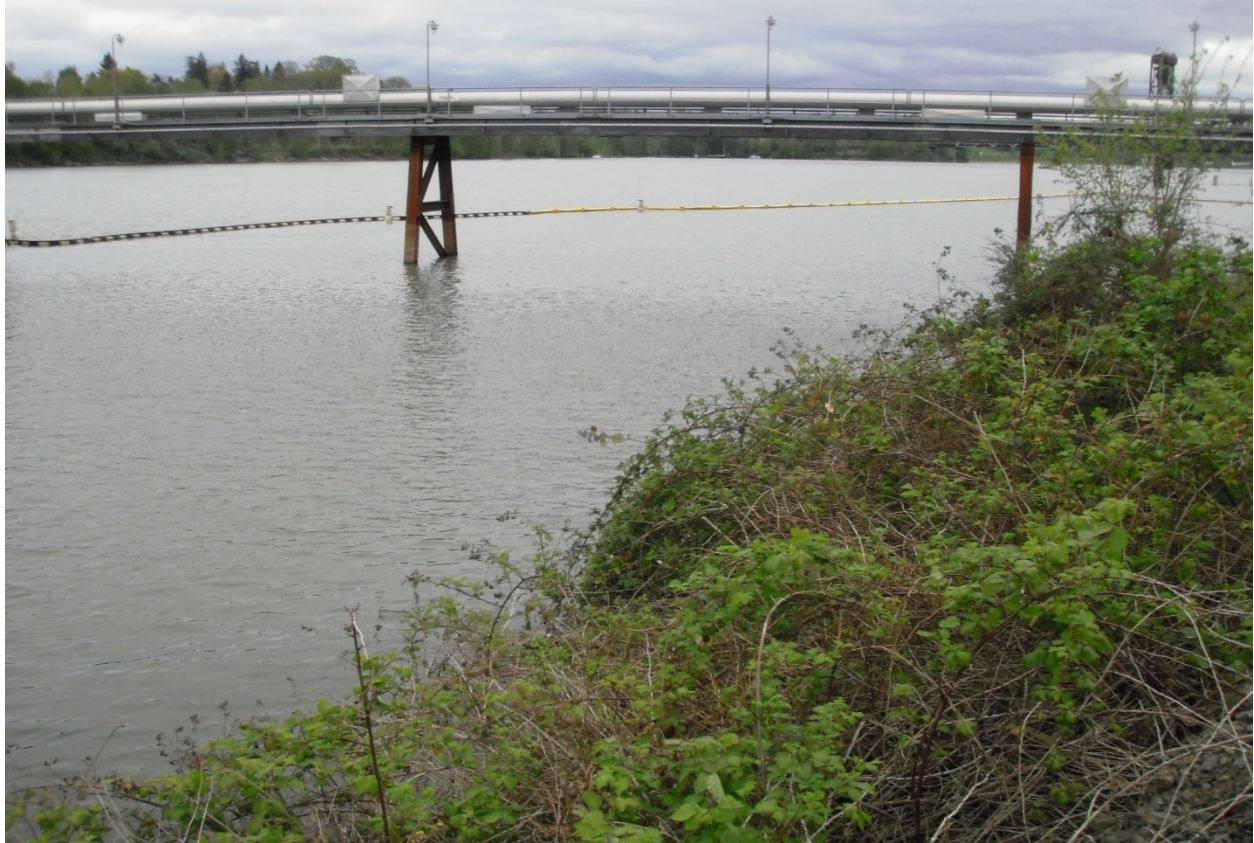
**Other Comments:** No sheen is evident in or around the cap area. Photo 3 shows the water surface and shoreline immediately downriver of the sediment cap.

Photo 3 — *Conditions immediately downriver of cap area (4/24/12):*
